ENGINEER'S REPORT

COMMERCIAL STRUCTURAL INSPECTION

12,000 s.f. BUILDING
AND
2,400 s.f. OUTBUILDING
LOCATED AT 10050 BEACH DRIVE, CALABASH

CRE Project No. 151101

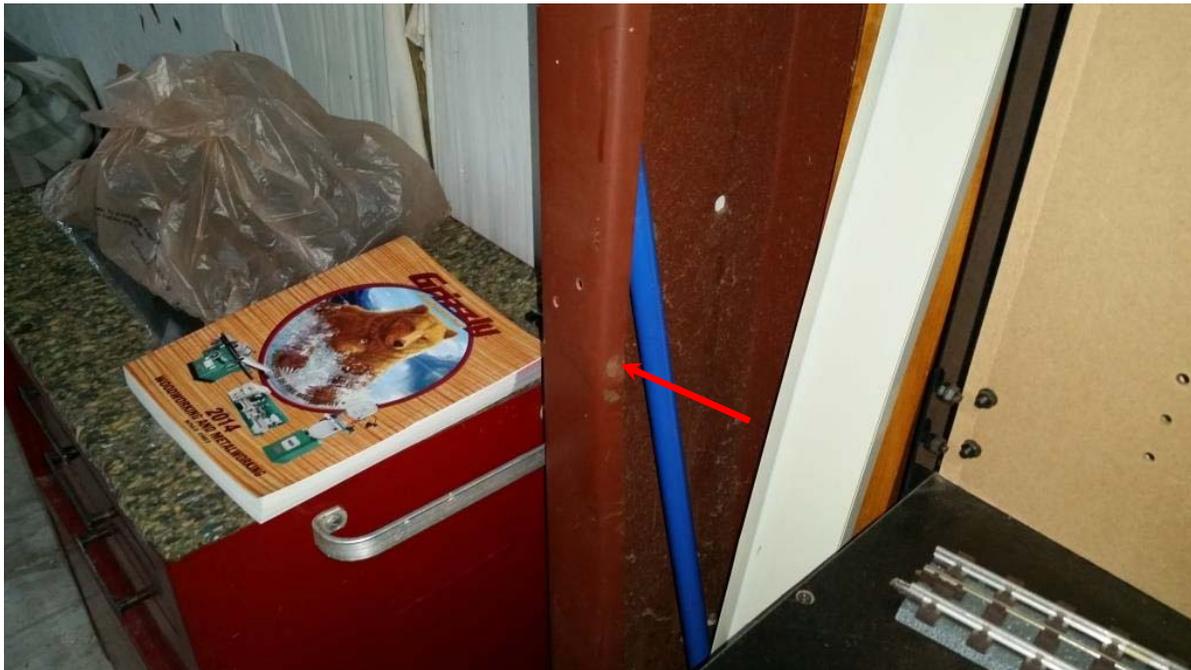
- l. All bolted connections are made with $\frac{3}{4}$ " or 1" bolts.
5. One column at the rear of the main section was slightly bent at the interior flange. See photos & recommendations.

- C) Corrosion of about 8' to 10' of exterior wall base at Left side at rear of open shed. Appears to be related to shed runoff.
- D) One rear wall column (beside door) in main section is dented, as if impacted by equipment at some time. The dent is minor, but should be addressed.

Dented Column

1. During renovation design development, make provision to strip interior cladding sufficiently to check all connections and support features, per (A) & (B) above.
2. Remedy limited exterior wall base corrosion at rear of open shed. Provide alternate shed rainwater collection if feasible.
3. Repair dented column (D above) by straightening, and scabbing a section of similar C channel to back side, lapping dent at least 18" each side.
4. Replace gutter ties and check eave & roof edge condition. Remedy as needed (roofing contractor).

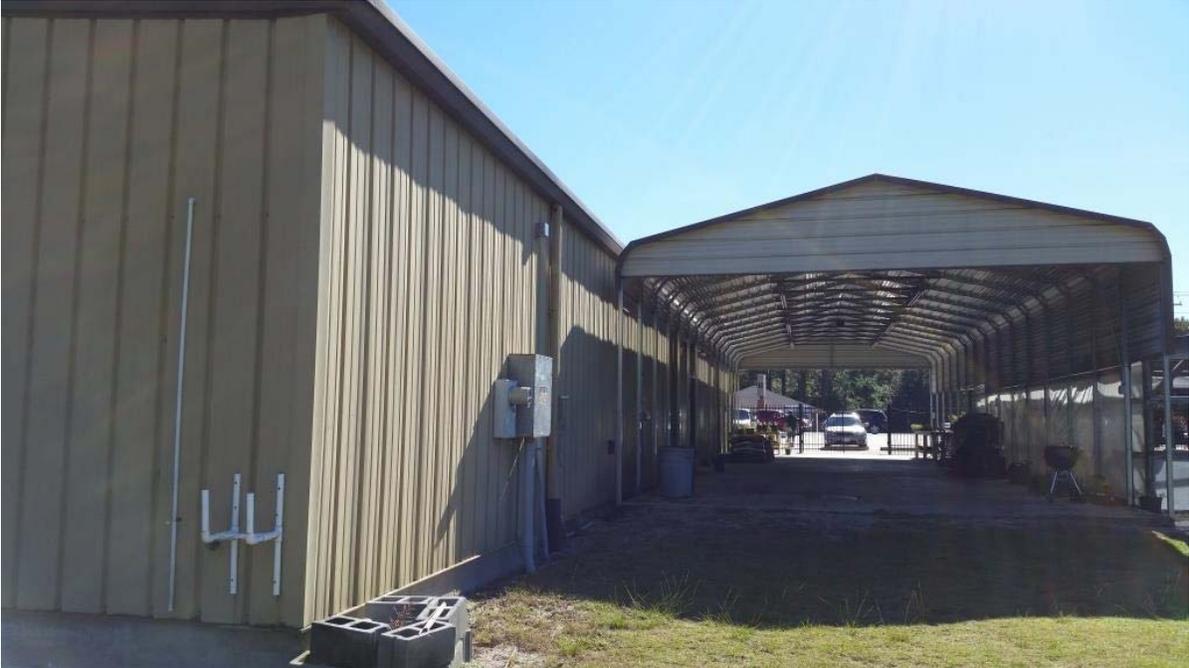
8. Facing the storefront, at left is an open shed adjoining the building. At the rear of this shed, Engineer noted that the exterior wall base shows heavier than normal rust. This area seems to be related to the adjacent rear of the shed roof, which likely experiences heavy runoff at the wall during rain.

Left Exterior Wall at Rear of Open Shed

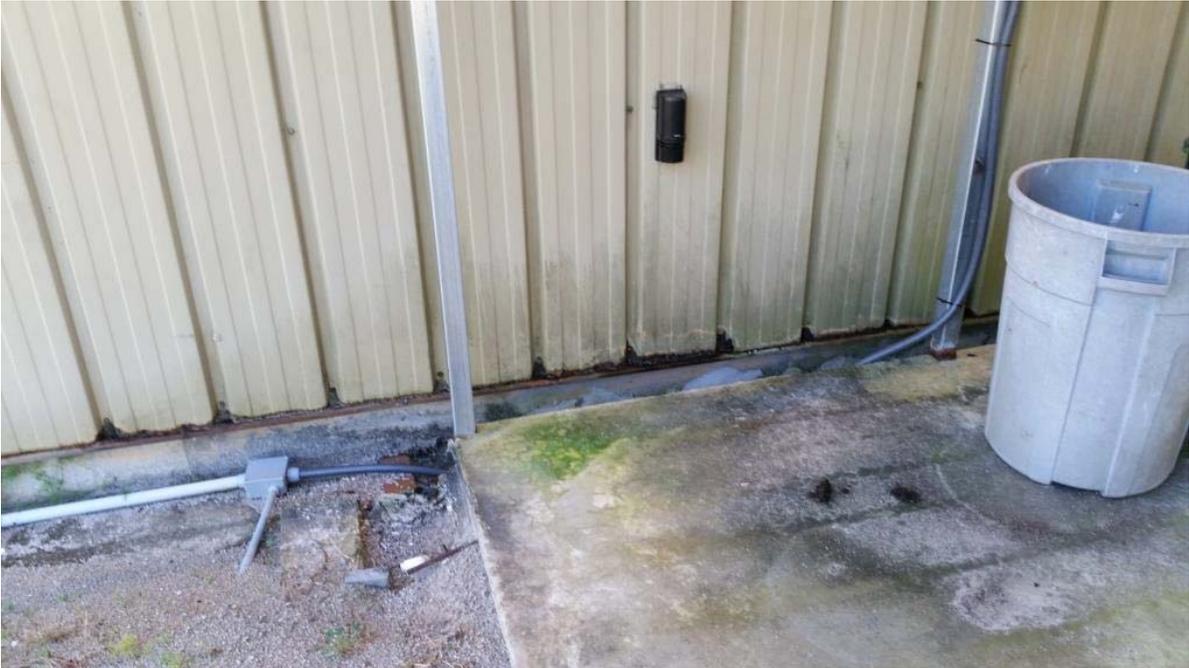
Corrosion at Wall Base – rear of Open Shed

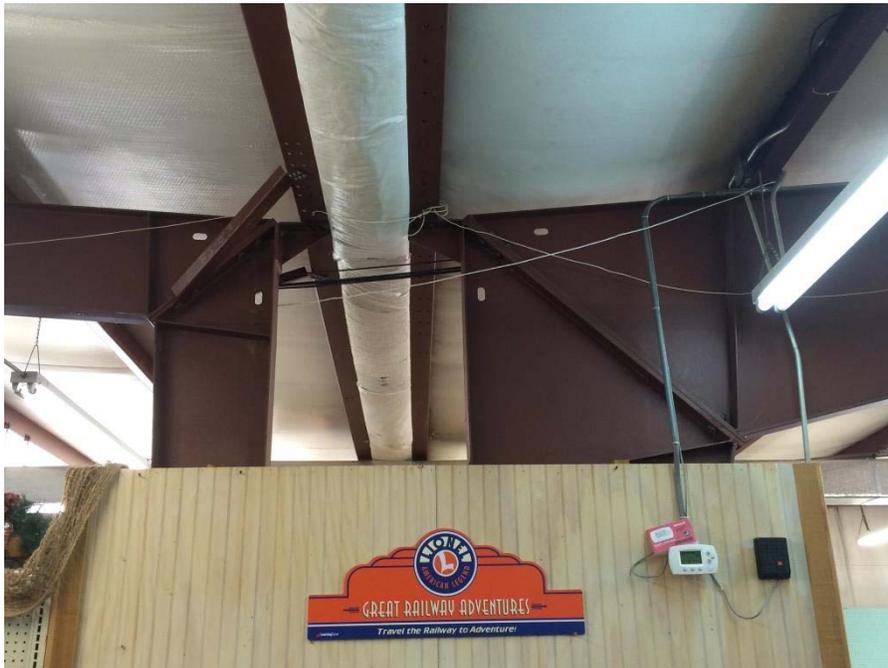
6. At the marriage line between the sections, a shallow valley is formed, and a gutter conducts to the rear of the building, to discharge into a large grate, presumably connected to storm water duct. It was reported by current owner that this gutter area had leaked in the recent past, has been repaired, and survived the recent heavy rains with no leakage.

Marriage Line – Inside

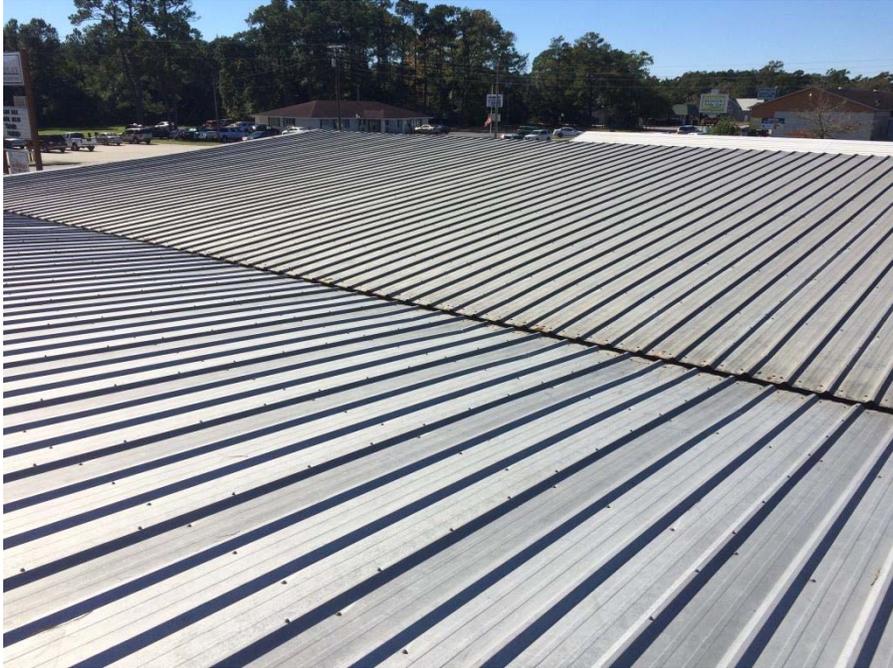
- E) Rusty gutter ties and rust at eaves on top of roof should be addressed.
- F) Rear canopy fascia material is dented – no structural issue.
- G) Past leakage of Cricket Gutter at roof marriage line – no current issue, but could recur in future.

Cricket Gutter above Marriage Line

5. Repair dented fascia sections (rear canopy, etc.) as required.
6. Have roofing contractor check the cricket gutter area and remedy as needed.

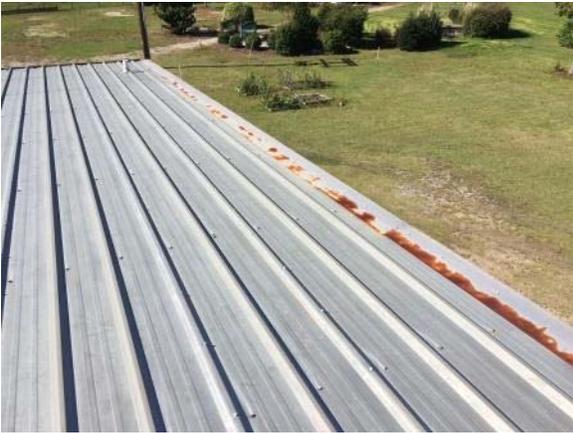
7. The roof cladding is in acceptable condition, excepting some rusty gutter ties and cap pieces. All rusty components were still serviceable, with surface corrosion. The roof should provide many years more of service.

Rusty Eaves

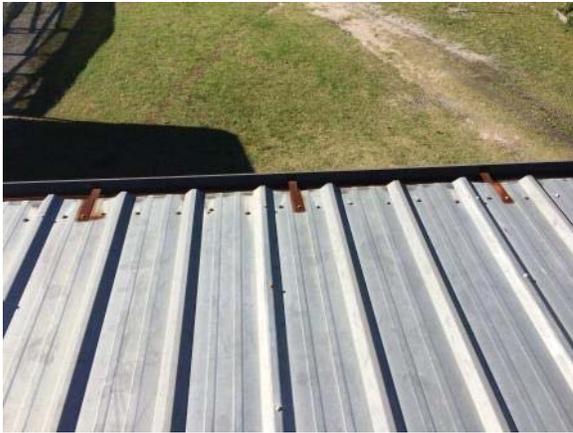
Rusty Gutter ties

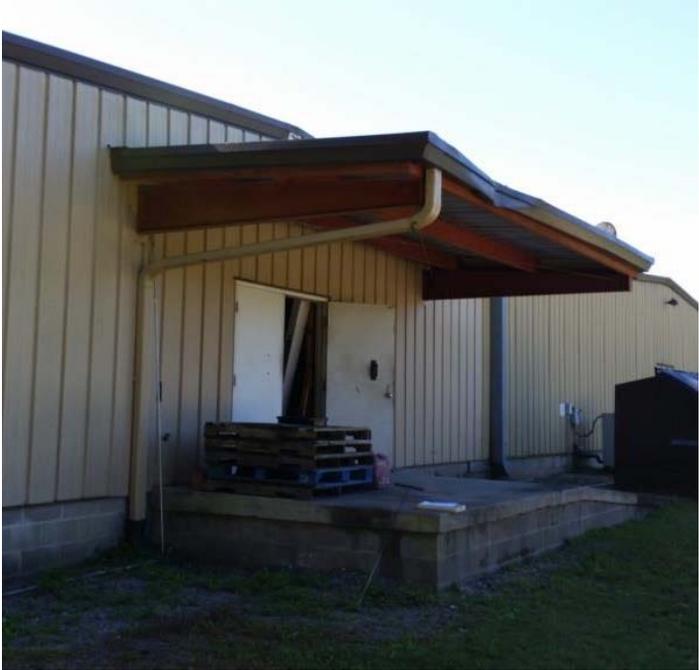
Rear Dock Canopy

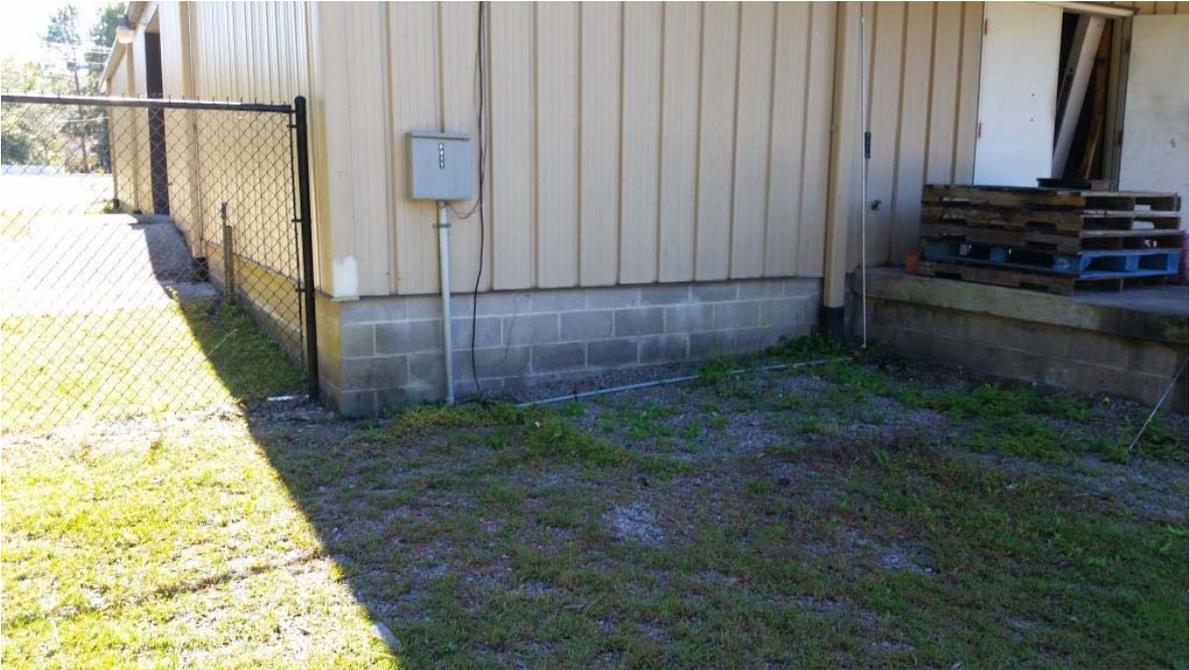
9. The foundation appears to be a raised 6" slab, on a masonry stem wall atop a buried concrete footer. No major slab cracking was visible, nor was any issue observed in the masonry stem wall. The footer appears to be buried 16" at the building front, reducing to 12" at the rear due to the slope of the site. Width of footer could not be determined, but appears to be adequately wide, as no foundation cracking or settling was evident in any location. It is presumed (no way to corroborate) that a compacted, engineered fill was installed under the slab – the lack of cracking would support this presumption.

Rear Lowest Corner – Footer 12” deep at this point
