ENGINEER'S REPORT

COMMERCIAL STRUCTURAL INSPECTION

12,000 s.f. BUILDING
AND
2,400 s.f. OUTBUILDING
LOCATED AT 10050 BEACH DRIVE, CALABASH

CRE Project No. 151101

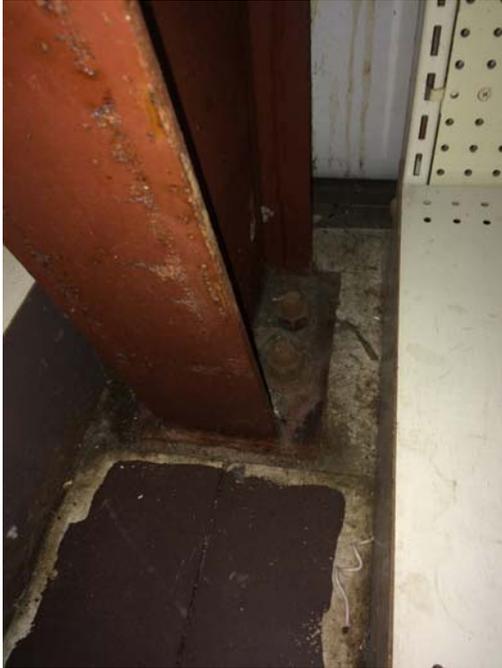
Typical MWFRS Base Anchorage

- e. Each main section column is anchored to foundation with four (4) bolts, apparently 1" diameter. Each addition section column is anchored to foundation with two (2) bolts, apparently 1" diameter.

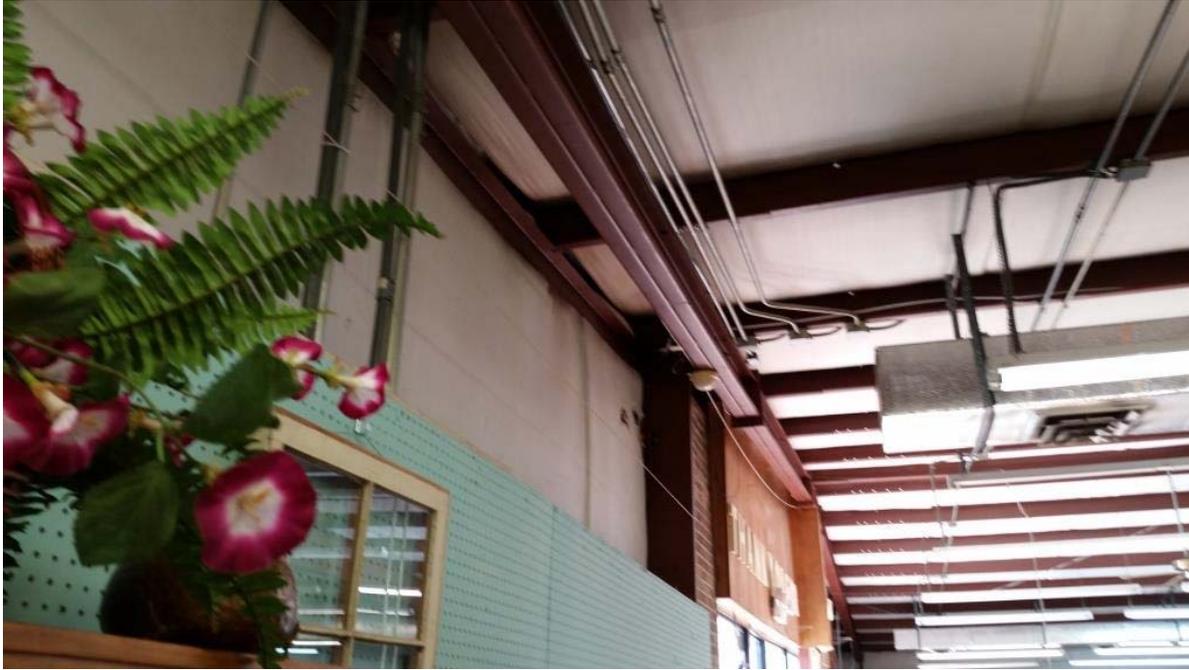
Main End Wall Framing

- f. Secondary columns (in end walls) are spaced at 20' maximum, and anchored to foundation (apparently with $\frac{3}{4}$ " anchors).
 - g. At least every other purlin is braced to the main beams with angle struts.

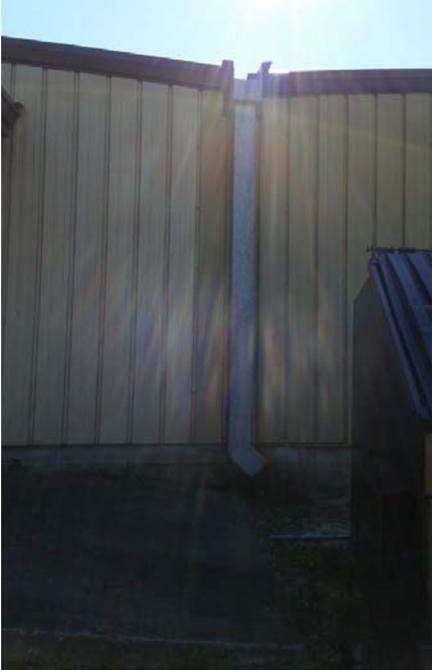
Rear Main Downspout

6. At the marriage line between the sections, a shallow valley is formed, and a gutter conducts to the rear of the building, to discharge into a large grate, presumably connected to storm water duct. It was reported by current owner that this gutter area had leaked in the recent past, has been repaired, and survived the recent heavy rains with no leakage.

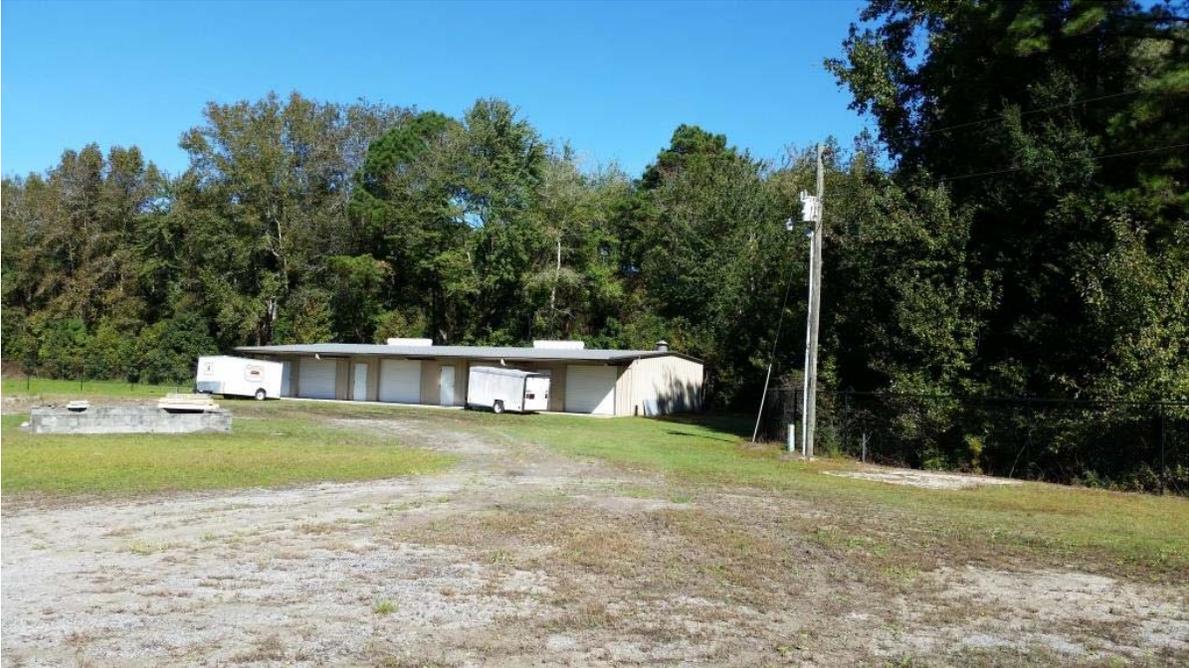
Outbuilding

12. The outbuilding is of similar construction to the main building, on a similar 6" slab over footer foundation.
 - a. Building is 30' x 80', divided into two sections with two bays each, served by roll doors.
